SERVICE BULLETIN

VHF, UHF 30 WATT AMP POWER CONNECTOR FAILURE

BULLETIN NUMBER: SB-0006
REVISION: A
DATE: NOV 2003

PRODUCT DESCRIPTION: VHF, UHF 30 WATT AMPLIFIER

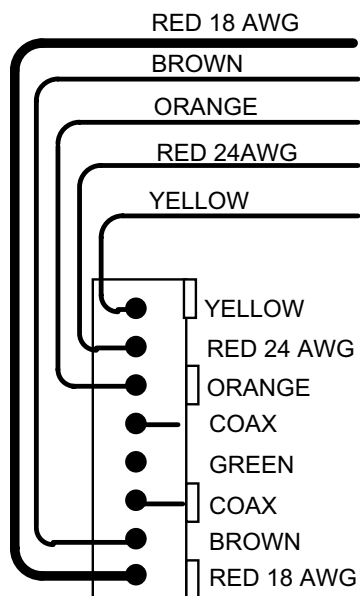
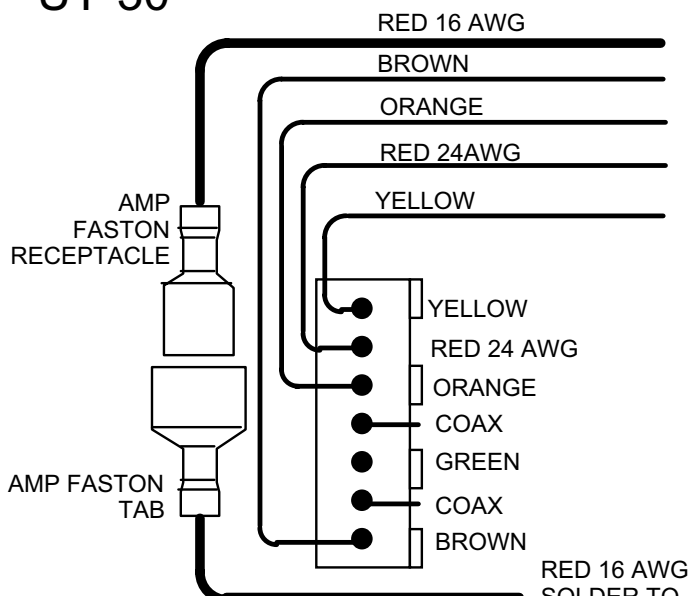
UT-30

BOTTOM VIEW OF MOLEX CONNECTOR

- 1) Replace the 8 pin housing (5022-156HS08L) with a 7 pin housing (5022-156HS07L).
- 2) Replace the 8 pin header (5022-156HD08L) on the sensor board with the 7 pin header (5022-156HD08L).
- 3) Replace Red wire for 13.8V power (between Sensor and power Switch) with two pieces of wire (7110-16S26302). Lengths of new wires are 10.5cm and 6.4cm. Crimp the AMP Faston Receptacle (5065-250R16A4) and the AMP Faston Tab (5065-250T16A4) to each piece of the 16AWG Red Wire.
- 4) The 16AWG wire can be soldered directly into the Sensor PCB header hole.

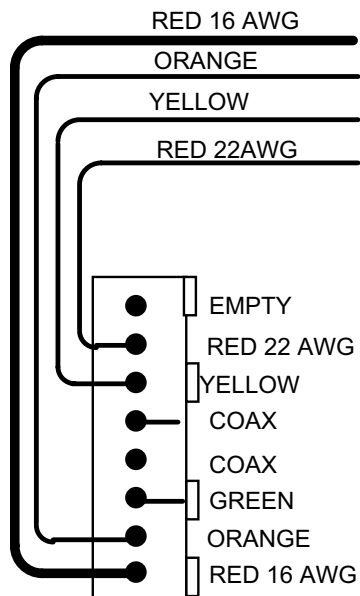
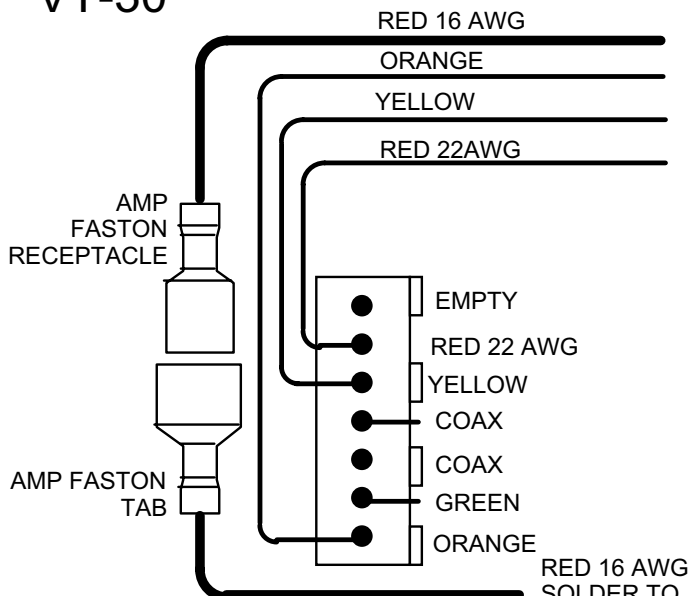
VT-30

BOTTOM VIEW OF MOLEX CONNECTOR

- 1) Replace the 8 pin housing (5022-156HS08L) with a 7 pin housing (5022-156HS07L).
- 2) Replace the 8 pin header (5022-156HD08L) on the sensor board with the 7 pin header (5022-156HD08L).
- 3) Replace Red wire for 13.8V power (between Sensor and power Switch) with two pieces of wire (7110-16S26302). Lengths of new wires are 10.5cm and 6.4cm. Crimp the AMP Faston Receptacle (5065-250R16A4) and the AMP Faston Tab (5065-250T16A4) to each piece of the 16AWG Red Wire.
- 4) The 16AWG will not fit into the original Sensor PCB header hole. The wire can be soldered directly to the Fuse Clip beside the header hole.
