SERVICE BULLETIN

AMP-2/150-30-00 TORQUE SETTINGS

BULLETIN NUMBER: SB-0009
REVISION: A
DATE: MAR 2004

PRODUCT DESCRIPTION: VHF 30W POWER AMPLIFIER

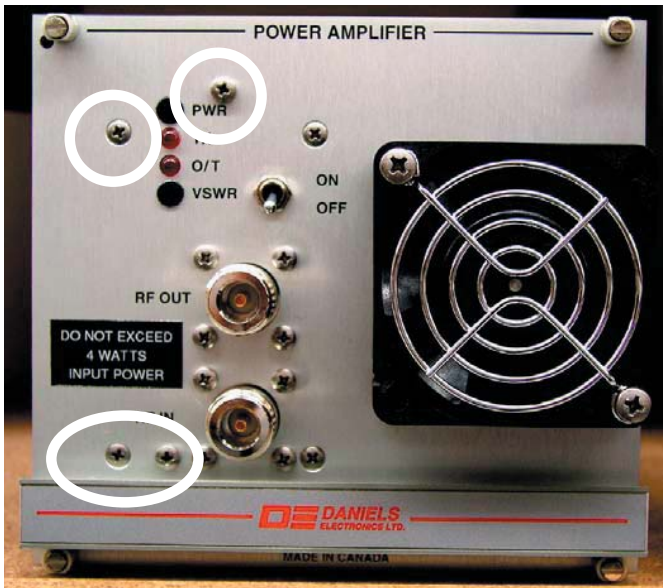
- 1 Remove four Front Panel screws.

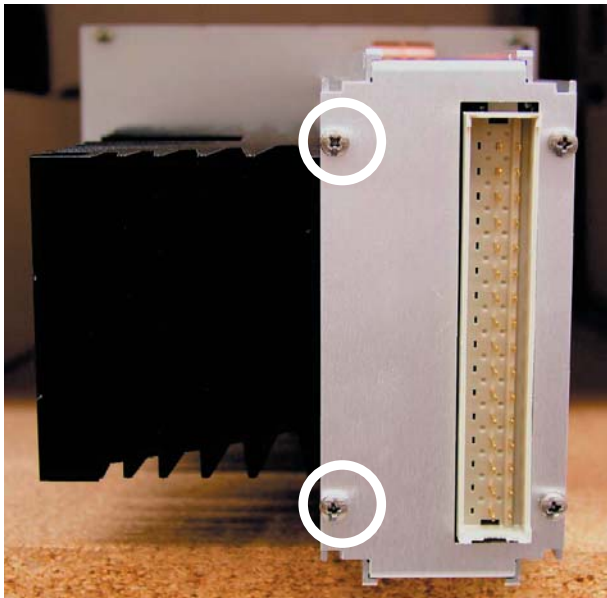
- 2 Remove two screws at the back.

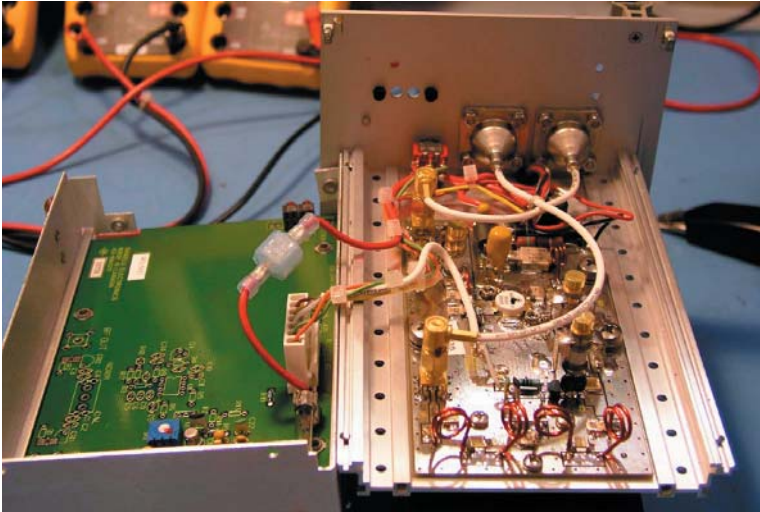
- 3 Open unit to expose the RF Amplifier board.

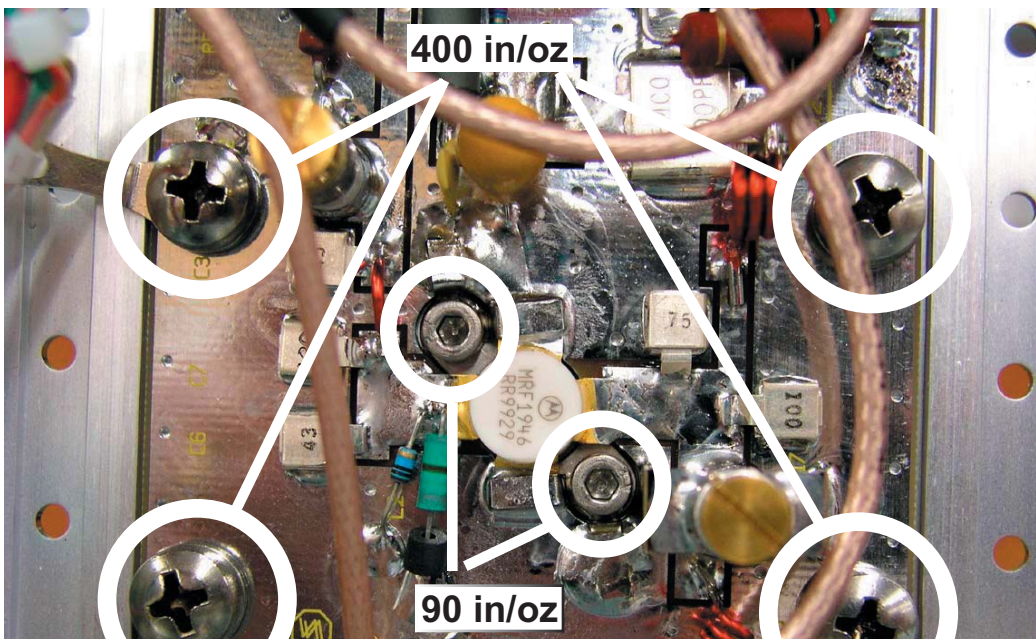
SYMPTOMS: CAP SCREW, M3x8 HEX SOCK-M2.5 5816-3M0SH08S on RF Amplifier Board may be loose. If the two CAP SCREWS are noticeably loose, these may be tightened using the appropriate torque driver.

CAUSE: Screws may not have been tightened properly during assembly.

- 4
 - Check that the two Hex Sock Screws have been tightened. The correct torque setting for these screws is 90 in/oz.
 - Check that the four M5x12 P/P screws holding the PCB to the side panel and into the heatsink, have been tightened. The correct torque setting for these screws is 400 in/oz (25 in/lb)

SOLUTION: Apply torque force of 90 in/oz to CAP SCREWS
